Rudder trim malfunction on initial climb, return to departure airport

Aircraft	ATR 72-212A registered F-OIQU
Date and time	25 June 2011 at 17 h 12
Operator	Air Tahiti
Place	On initial climb, after take-off from Papeete (French Polynesia) airport
Type of flight	Scheduled public passenger transport
Persons on board	Captain (PF), copilot (PNF)
Consequences	None

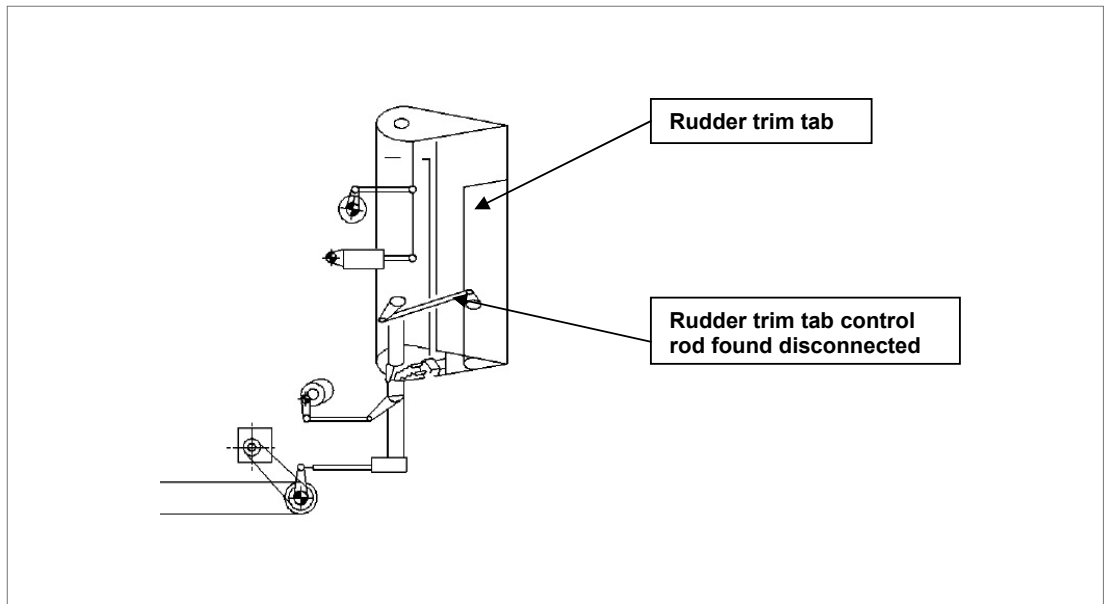
The maintenance operation carried out after the incident showed that the trim tab control rod was not connected.

Diagram of the rudder trim tab

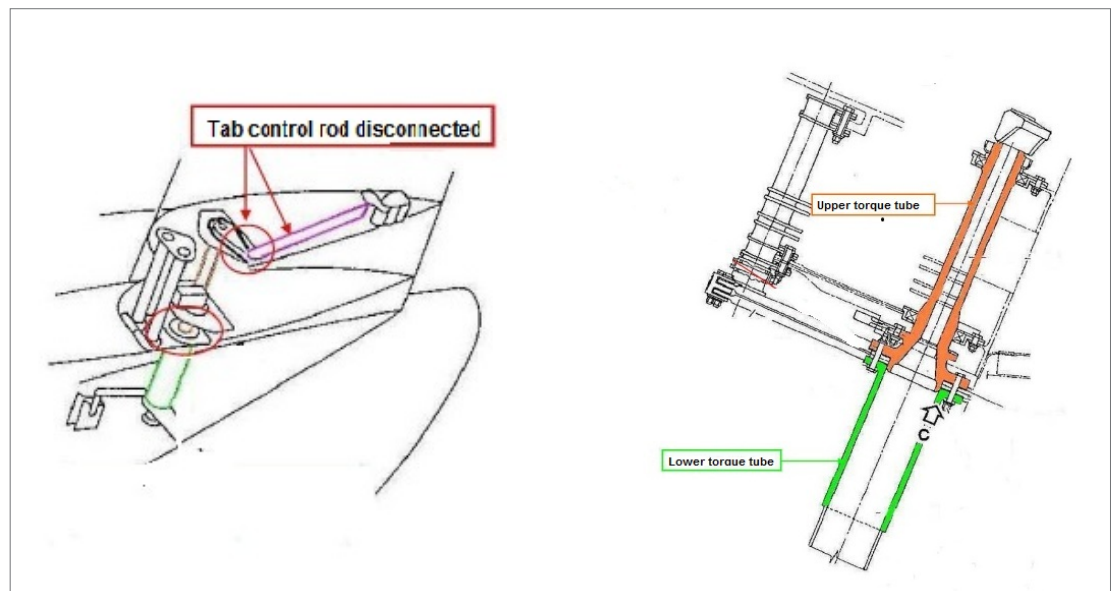
On 10 June 2011, a detailed inspection of the rudder control torque tube showed corrosion between the lower and upper sections. The upper section was located in the rudder and the lower section was in the rear fuselage cone. The two sections were linked by a screw-lock crown.

Position and diagram of the rudder control torque tube
